# **Bed Stiffener/ Tie Down Point**

Part# 48677 - 2007+ Tundra

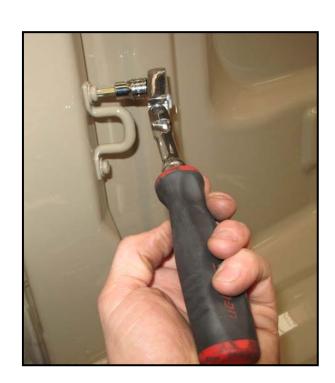
1. Use a T-40 Torx bit to remove the stock bed tie down bracket.

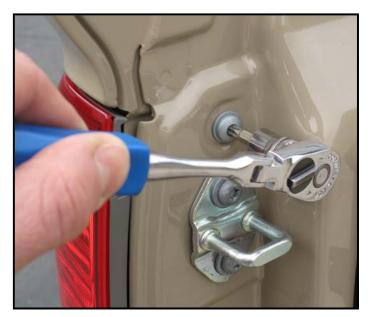
2. Use a T-30 Torx bit to remove both tail light bolts, then remove the tail light (pull the tail light out towards the side of the vehicle being careful to not brake the plastic clips).

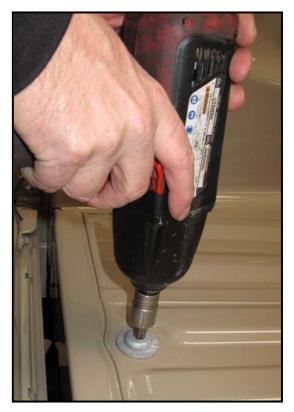
3. Use a T-55 Torx bit to remove the bed hold down bolt.

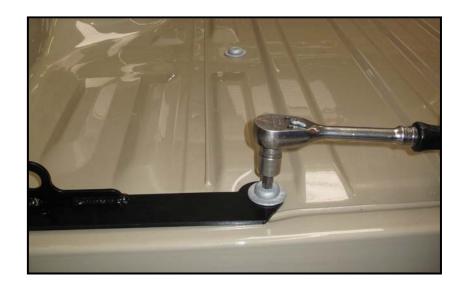
5. Thread the bed hold down bolt through the bed stiffener but do not tighten.

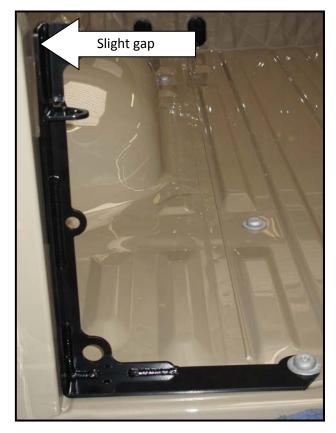
6. There will be a slight gap between the bed stiffener and the bed, this gap will cinch up when all the bolts are tight.

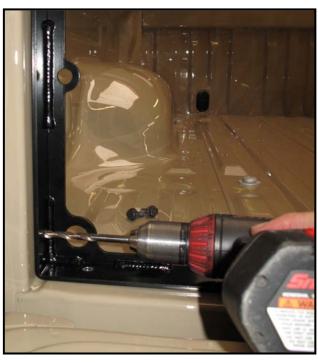
8. Insert and tighten the supplied 5/16" bolt, washers and nut in the bottom bed hole using a 1/2" wrench and socket, then drill the bottom hole in the bedside.

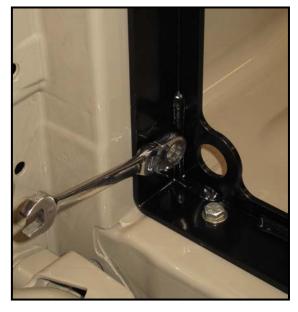
9. Insert and tighten the supplied 5/16" bolt, washers and nut in the bottom bedside hole using a 1/2" wrench and socket, then drill the top hole in the bedside.

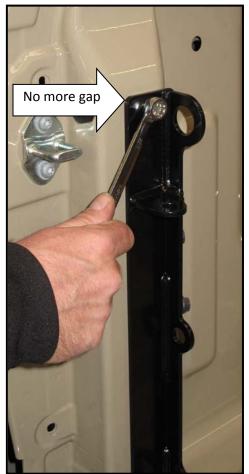
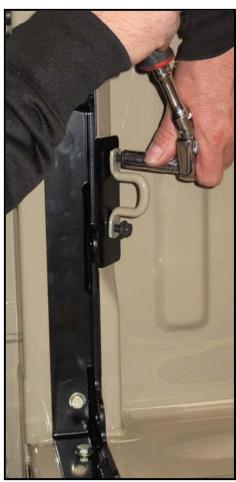
10. Insert and tighten the supplied 5/16" bolt, washers and nut in the top bedside hole using a 1/2" wrench and socket. While tightening this bolt you will see the previously mentioned gap disappear. Also tighten the stock tie down bracket using a 13mm wrench.

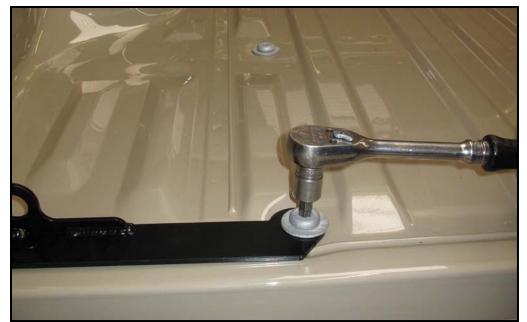
11. Use a T-55 Torx bit to tighten the bed hold down bolt.

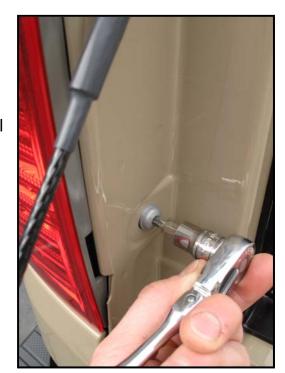
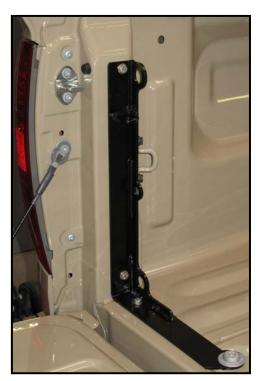
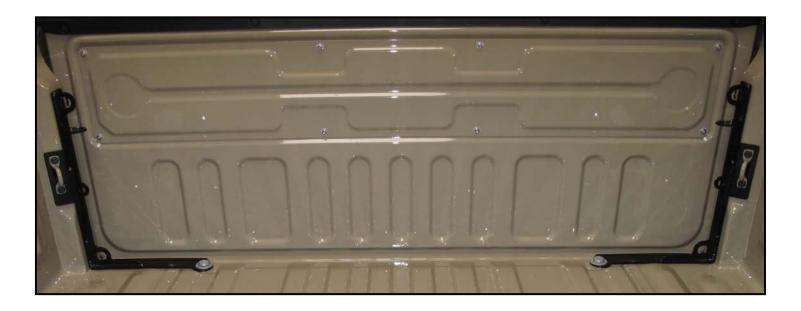
12. Make sure all the hardware is tight and re install the tail light using a T-30 Torx.
