INSTALLATION INSTRUCTIONS

**COMPONENT:
STOCK LENGTH LOWER CONTROL ARMS**

**1996-2004 TACOMA
1996-2002 4RUNNER
1996-2002 PRADO 90**

PART #: 96555-E

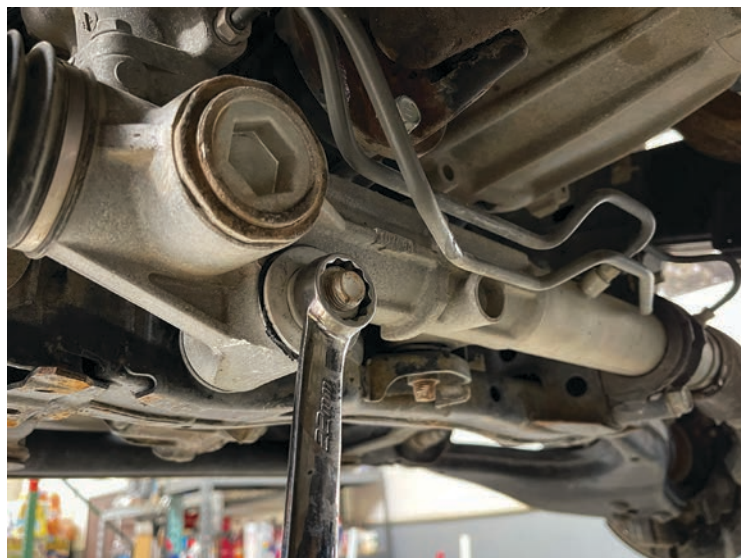
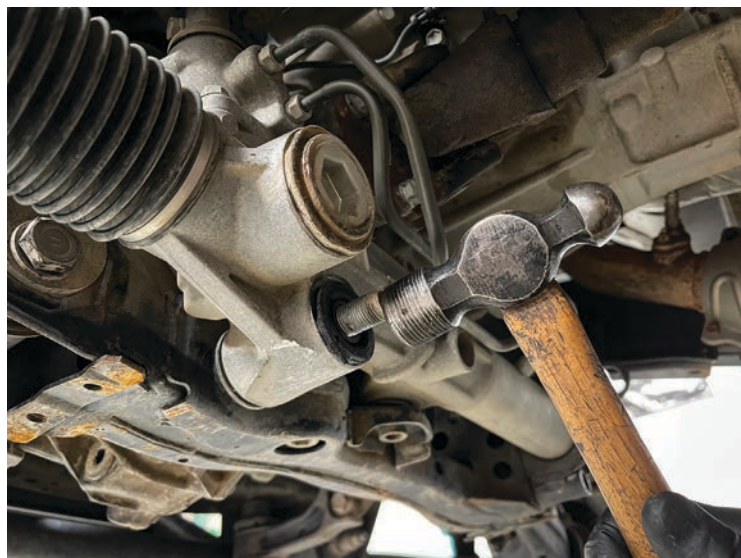
STEP 1

Use a 22mm wrench to loosen and remove the nut from the steering rack through bolt. Tap the bolt forward so that it no longer goes through the steering rack.

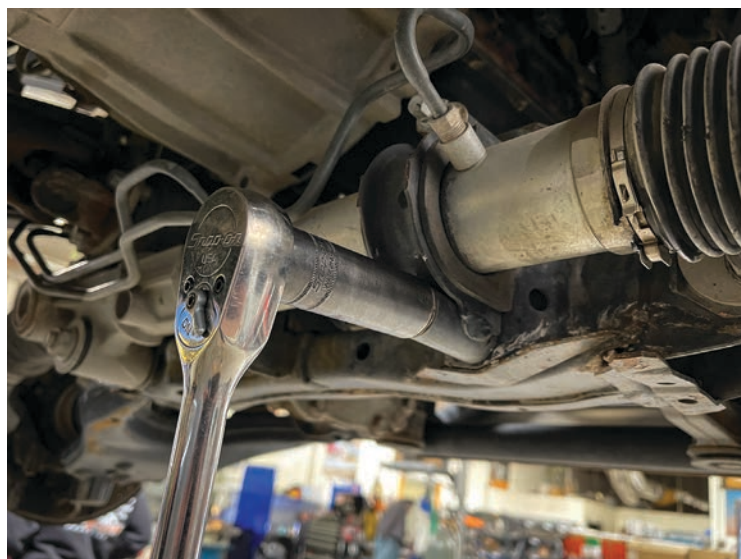
STEP 2

Use a 19mm socket to loosen and remove the “D” bracket that secures the steering rack to the frame.

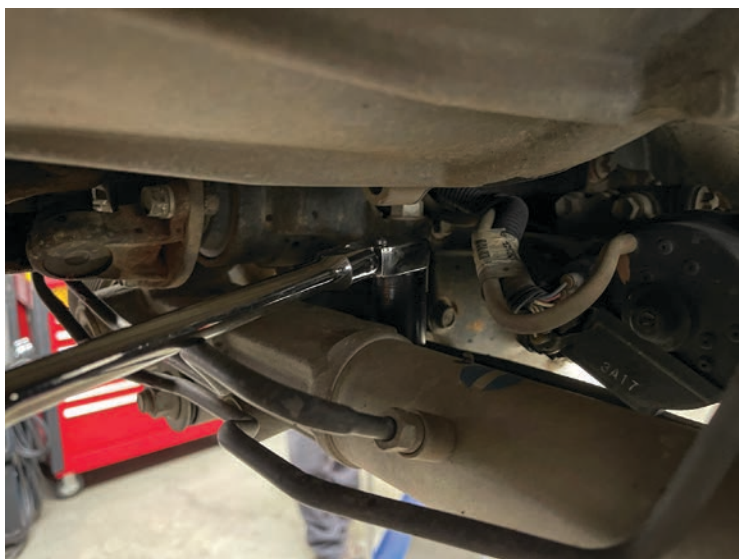
STEP 3

Use a 19mm socket to remove the final rack bolt that is under the bellhousing and faces downward.

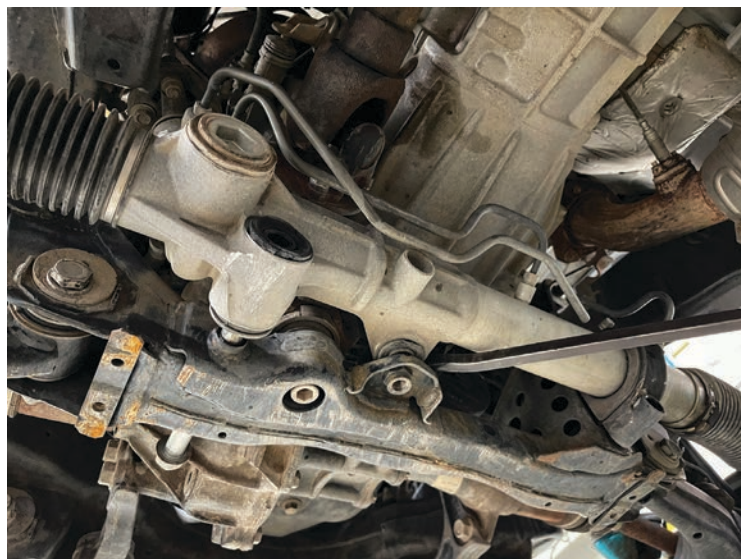
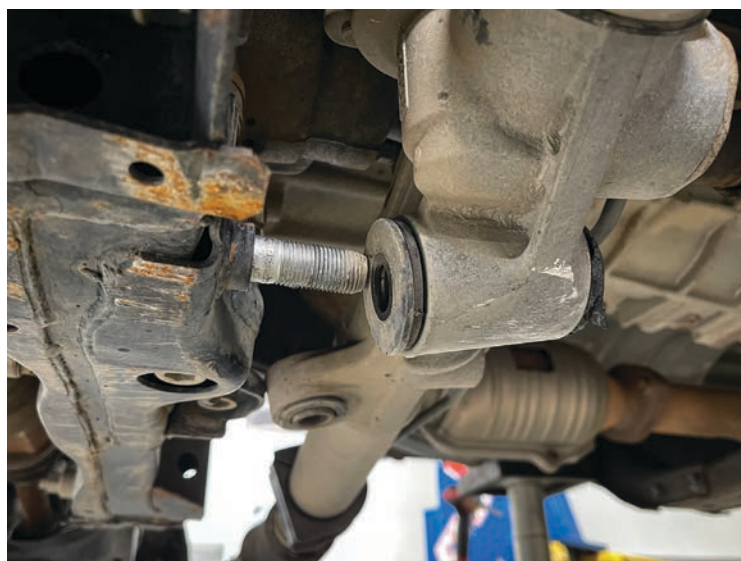
STEP 4

With the rack hardware removed, pull the rack back and out of the way of the lower control arm hardware.

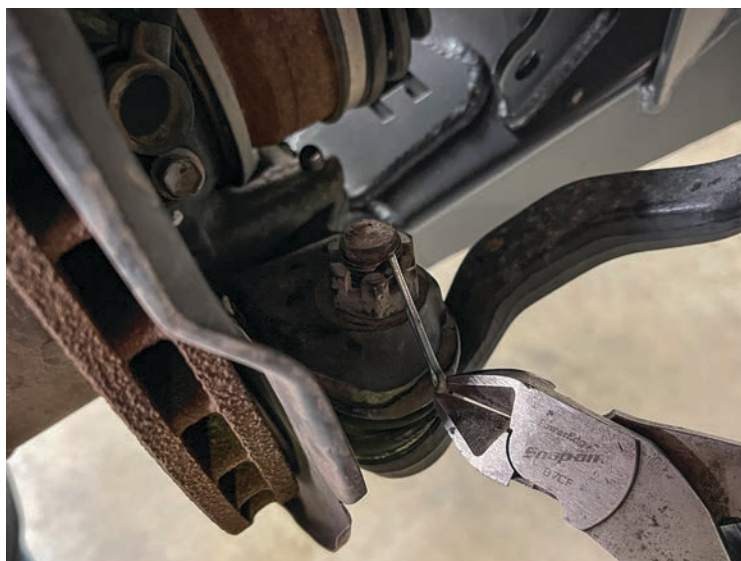
**STEP 5**

Start to remove the factory tie-rod by pulling out the cotter pin.

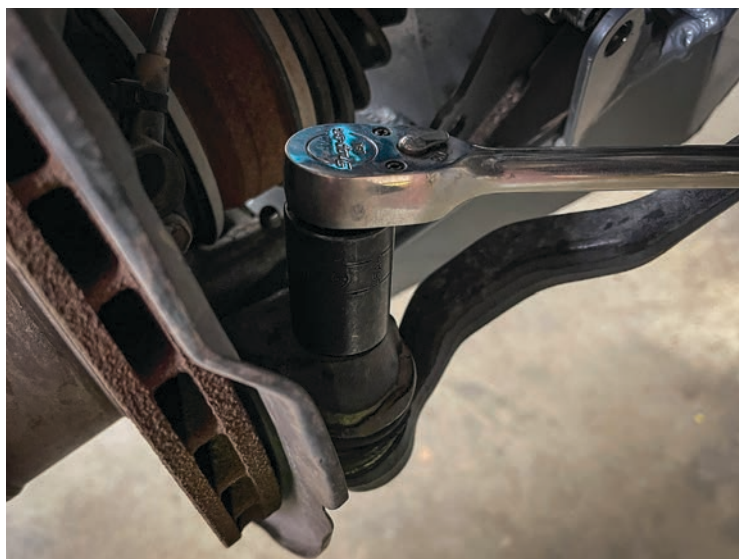
STEP 6

Loosen the castle nut but do not fully remove it.

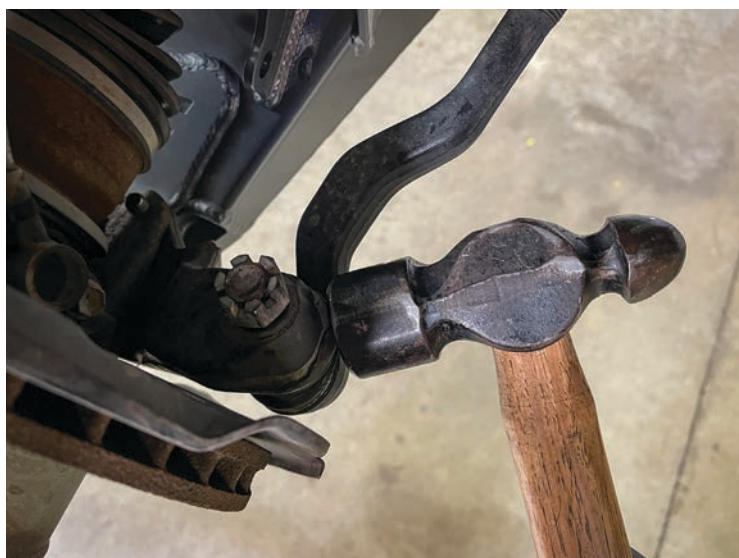
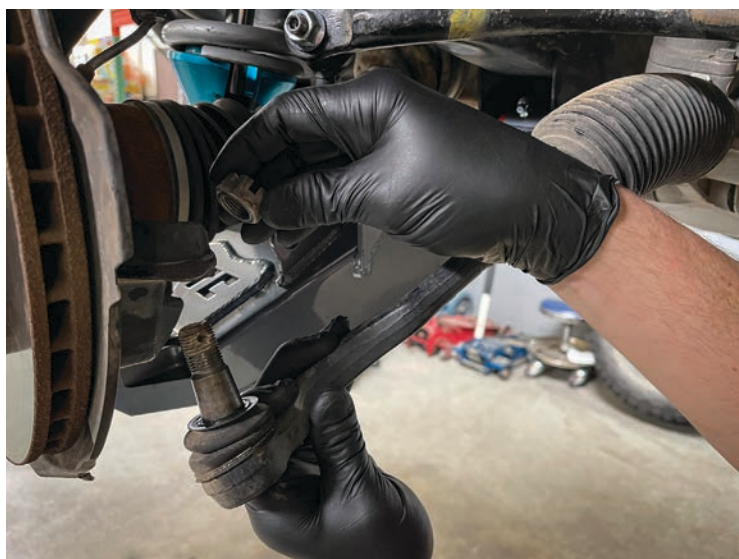
**STEP 7**

Strike the lower ball joint to knock the tie-rod taper loose. Once it pops free, remove the castle nut and separate the tie-rod from the lower ball joint.

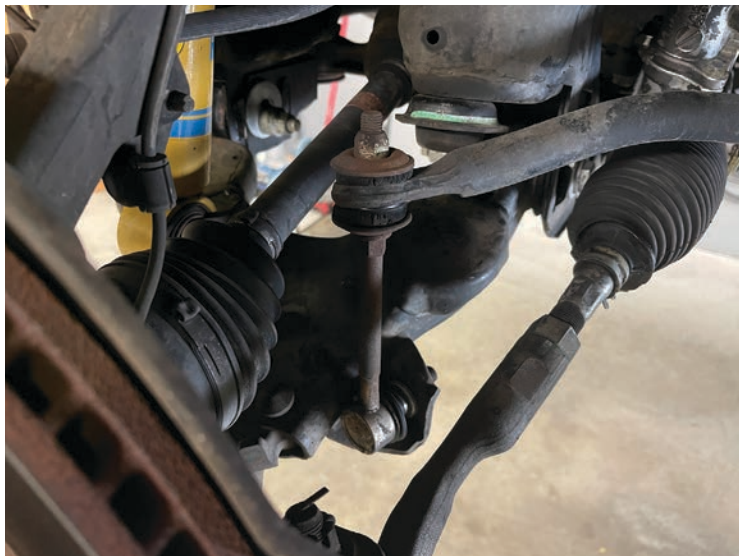
STEP 8

If a sway bar is on the vehicle, remove the hardware that connects it to the lower control arm.

*4Runner sway bar shown in image. Tacoma will vary slightly but the process is the same.

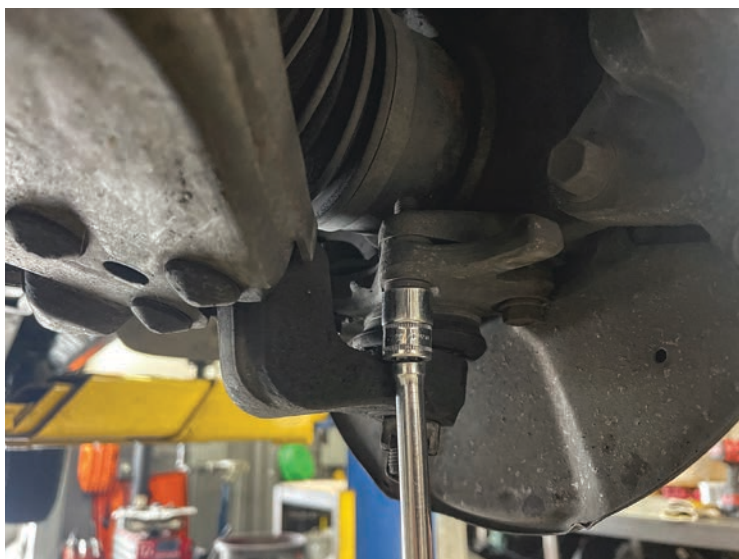
STEP 9

Remove the (4) 14mm head bolts holding the old ball joint to the steering knuckle.

It is unnecessary to fully remove the old ball joint from the factory lower control arm since you'll be replacing them with new ones.

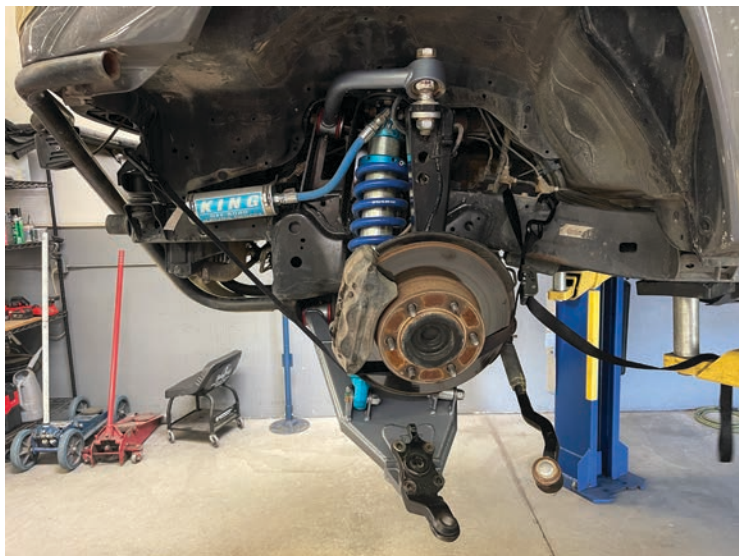
STEP 10

Use a tie-down strap routed under the hub to raise the steering knuckle and brake assembly up and out of the way. This will make removing the lower ball joint much easier.

(Image shows a TC lower arm but the process is the same with the factory LCA on the vehicle.)

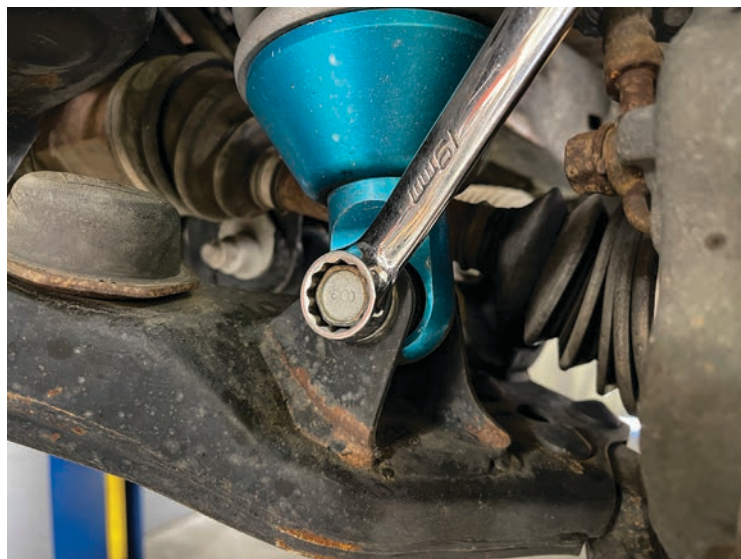
STEP 11

Use a 19mm to loosen and remove the lower shock bolt.

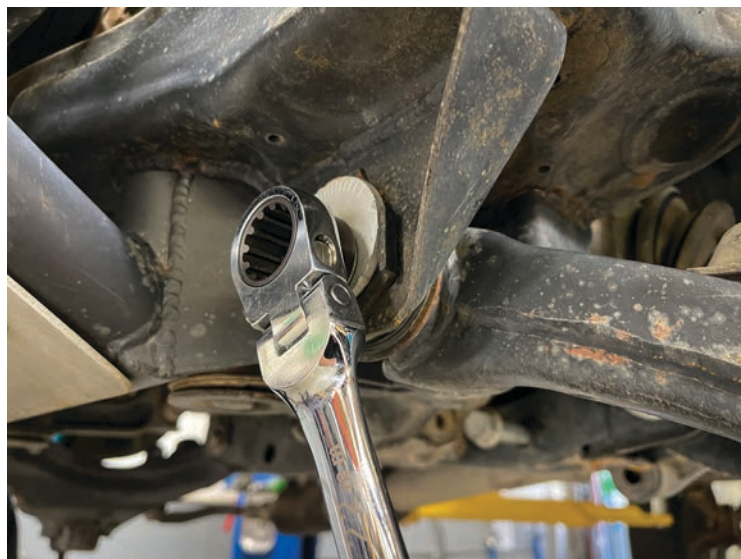
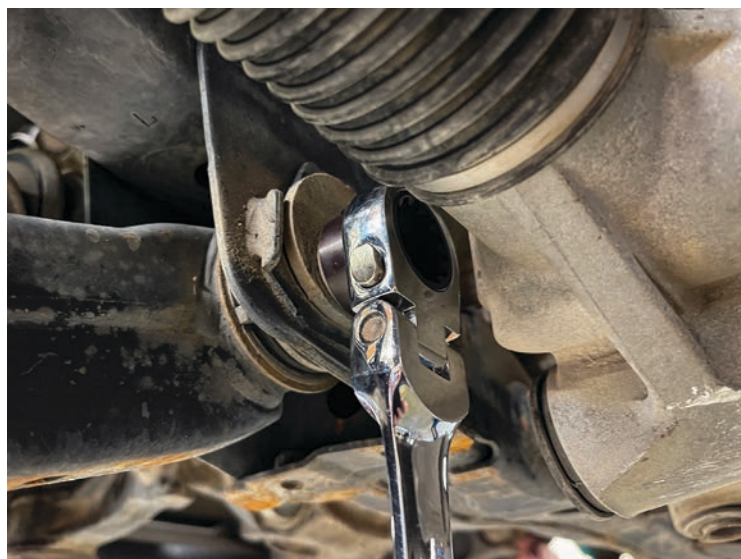
**STEP 12**

Supporting the arm in one hand, loosen the lower control arm eccentric cam bolts, and lower the arm letting it hang.

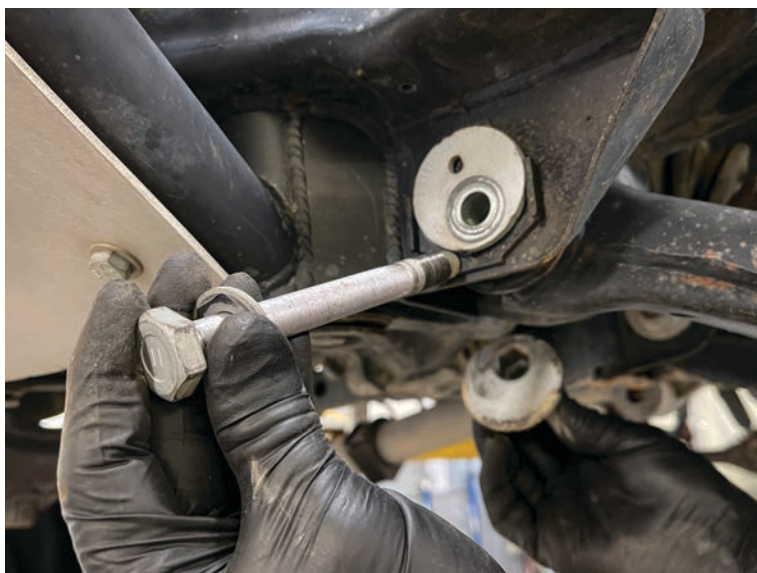
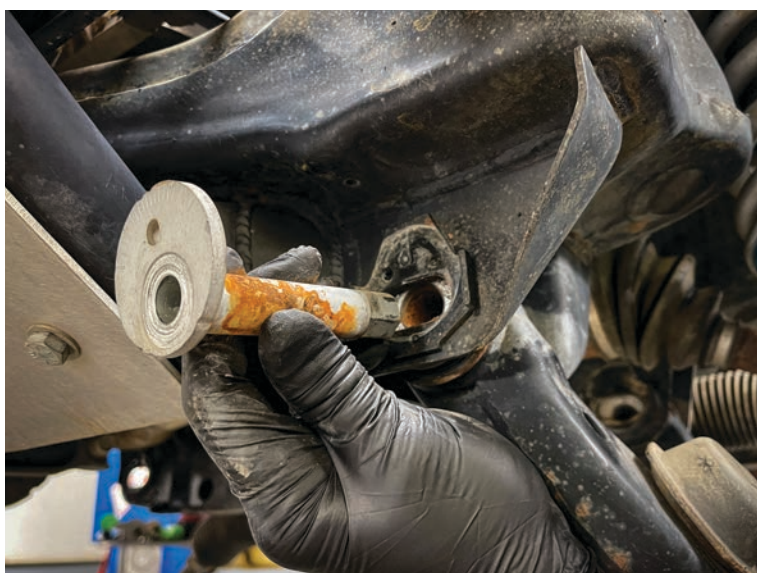
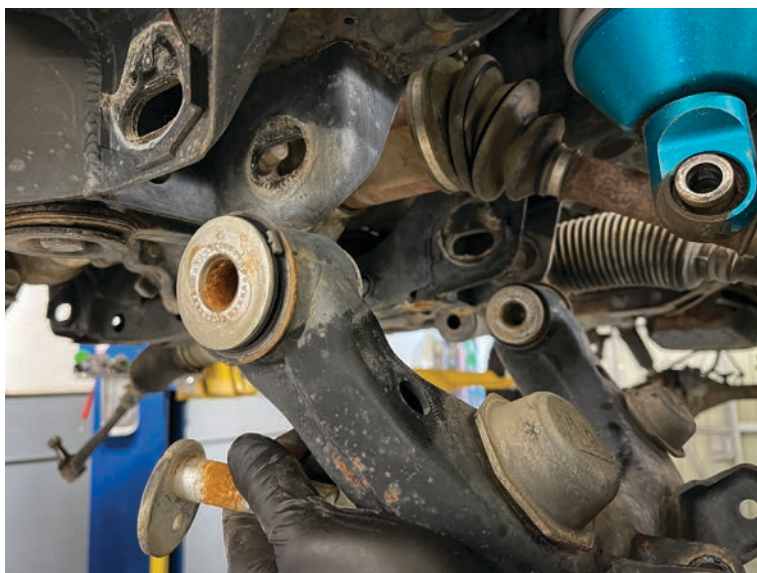
STEP 13

Support the control arm as you remove the cam bolts to completely remove the arm from the vehicle.

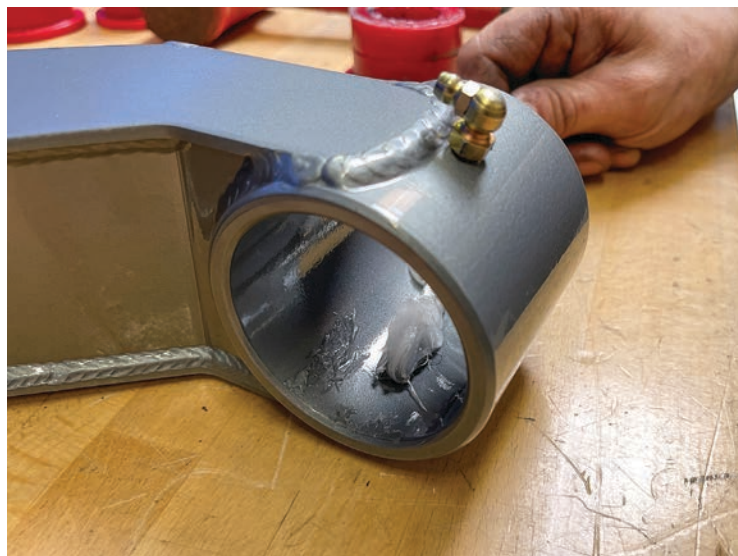
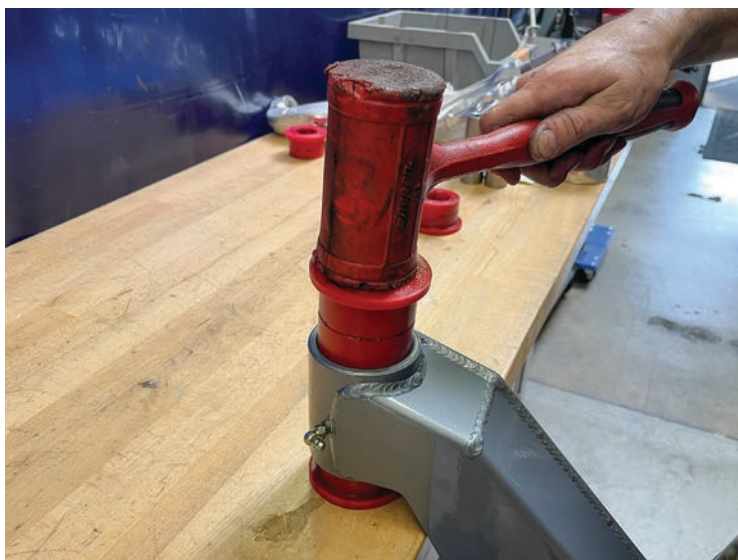
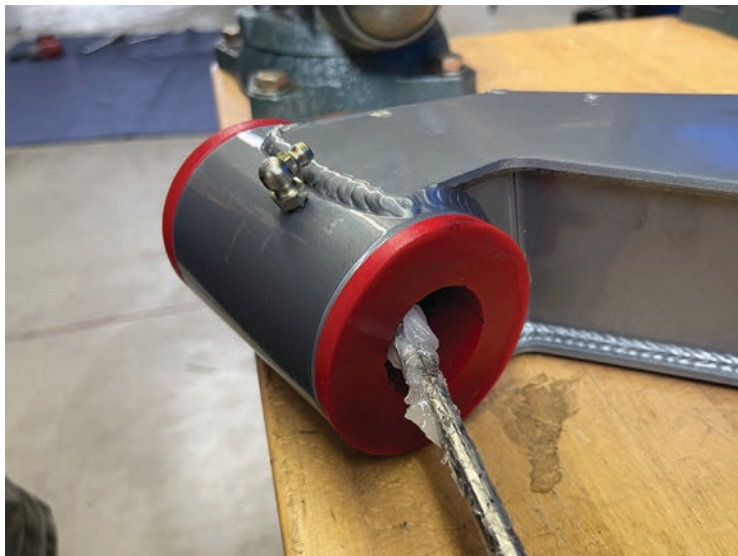
STEP 15

Grease and install the new bushings and inner sleeves.

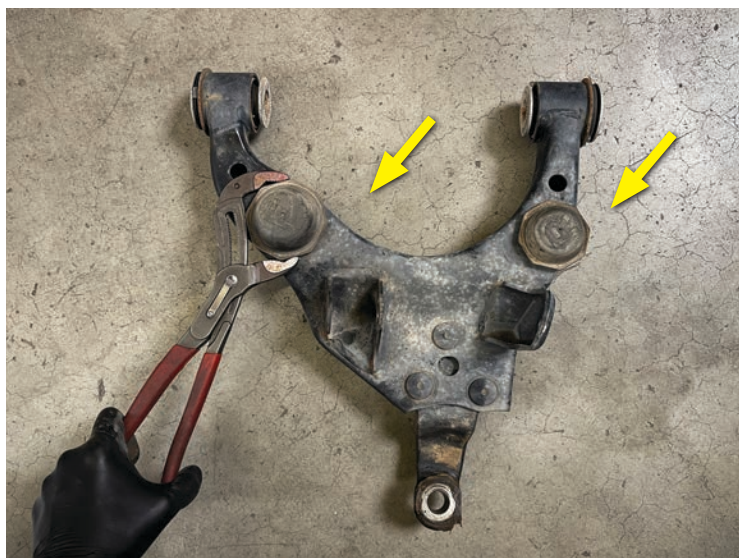
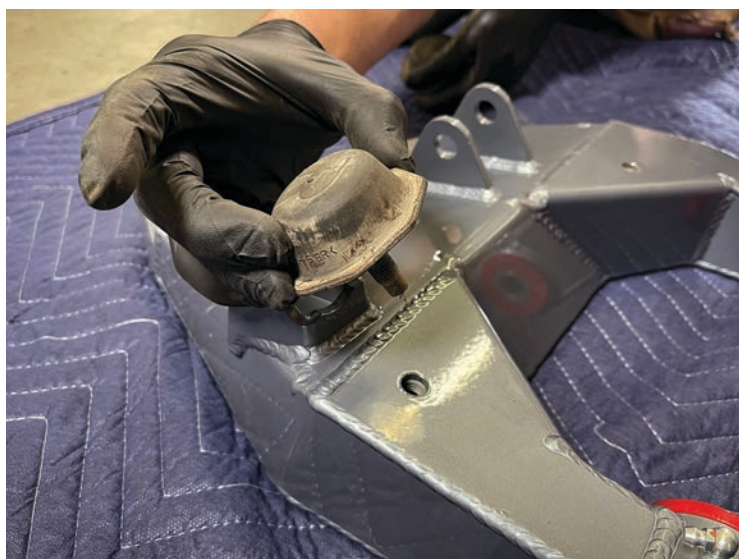
**STEP 14**

Remove the OEM bump stops from the stock lower control arm and thread them into the 96555-E.

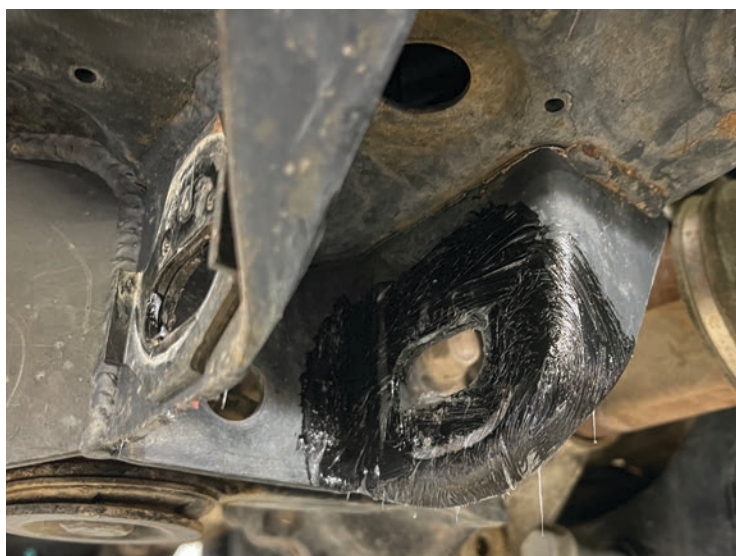
**STEP 16**

Grease the frame pocket where the LCA bushings will ride on the frame.

NOTE: It may be necessary to use a rubber mallet to slightly open up the frame pockets to ease the installation of the new lower control arm.

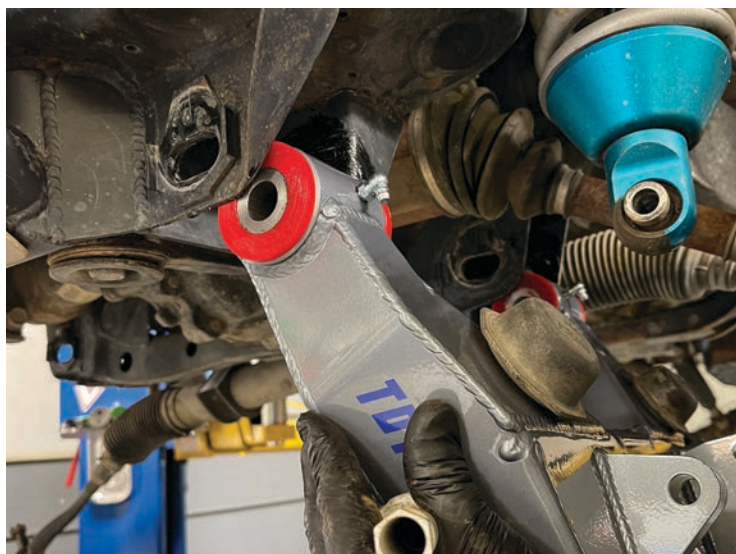
**STEP 17**

Slide the new control arm into the frame and reinstall the alignment cam hardware.

Then reverse steps 1-4 to reinstall the steering rack.

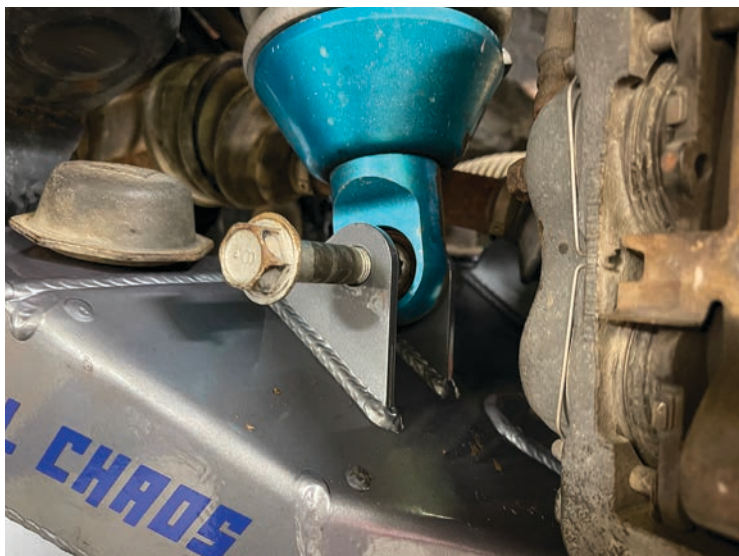
STEP 18

Swing the new LCA up and reinstall the lower shock bolt so the arm will be held in place.

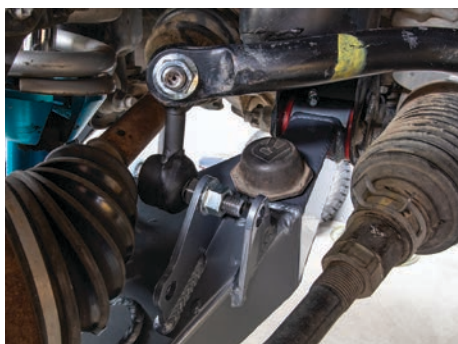
1996-2004 Tacoma

If the sway bar is being retained or a secondary shock is being installed, reference the photos below to ensure the component is mounted in the correct holes.

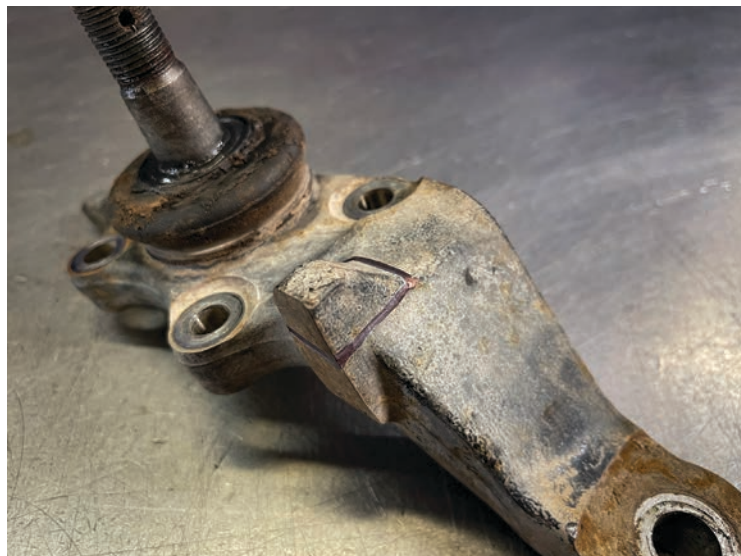
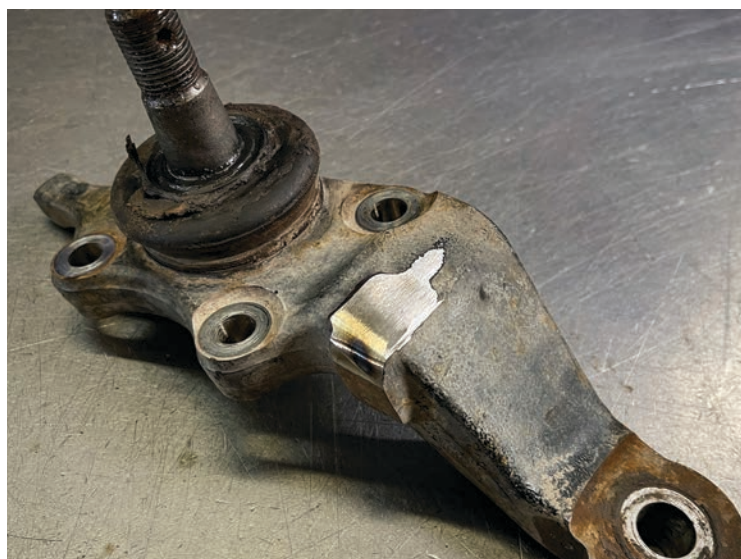
STEP 20

Trimming the new factory lower ball joint steering stop is necessary for clearance purposes.

The nub to trim down is marked with a sharpie. A band saw and a belt sander will work best.

Once trimming the sanding is complete, use black spray paint to coat the exposed area.

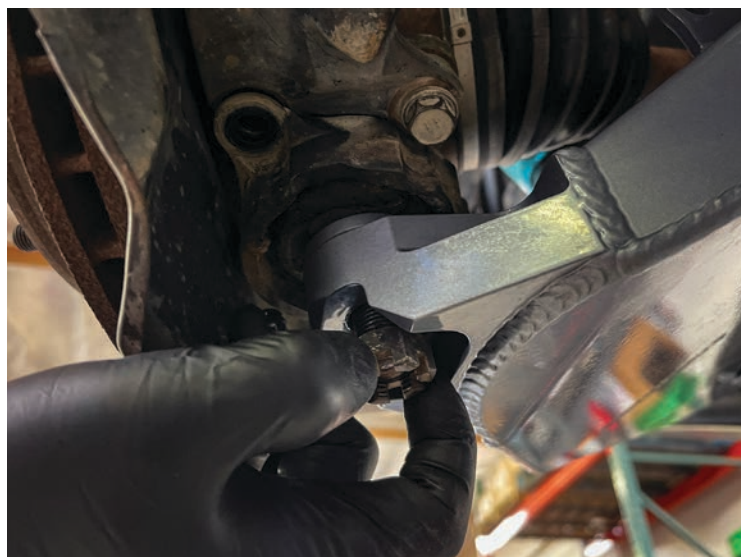
**STEP 21**

Insert the new ball joint into the lower arm and torque the castle nut to 103 ft/lbs. Once torqued, install a new cotter pin.

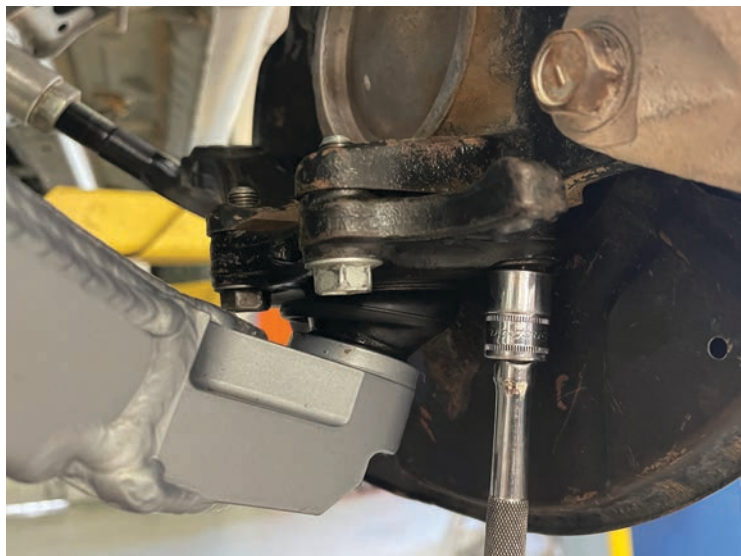
STEP 22

Reinstall the (4) lower ball joint bolts into the knuckle and torque to 45 ft/lbs.

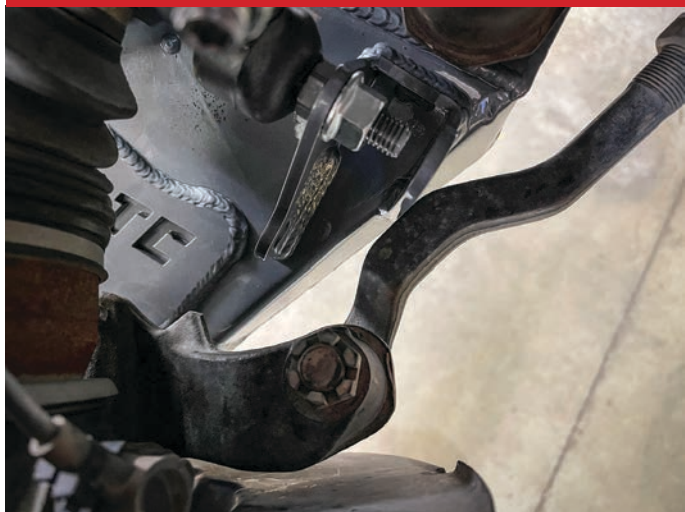
INCORRECT

For clearance purposes, 1996-2004 Tacoma requires a factory outer tie-rod swap from left to right and right to left. See images below.

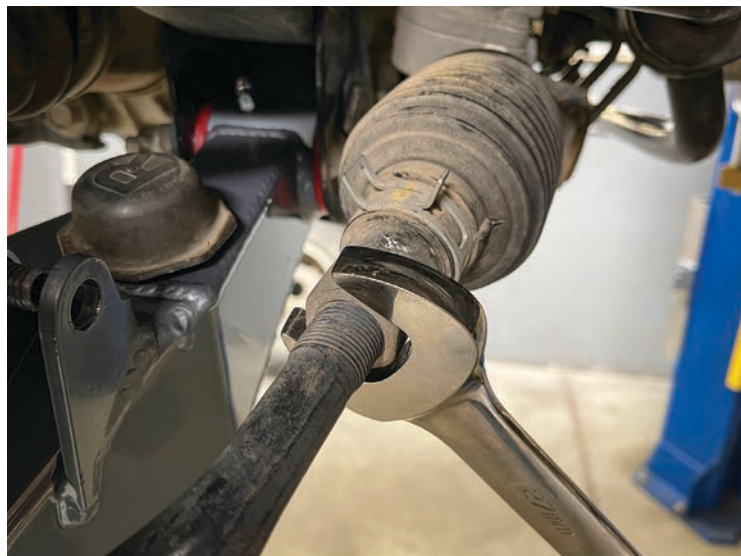
STEP 23

Loosen the outer tie-rod jam nut slightly, then remove the entire outer tie rod.

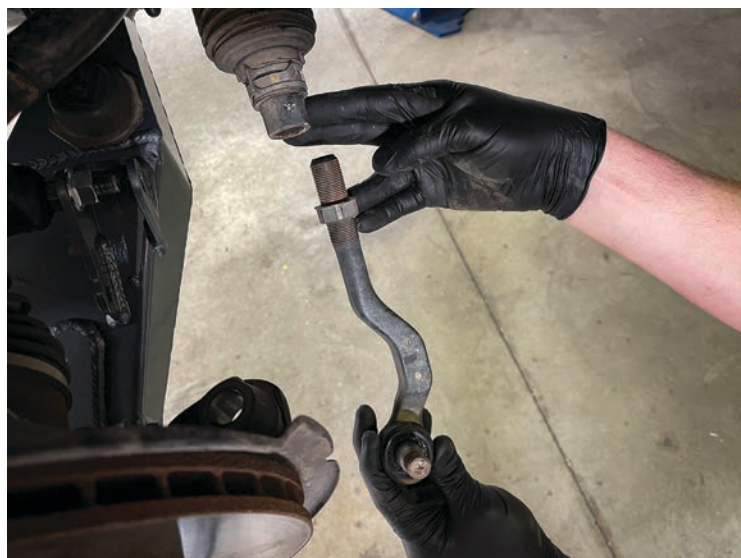
Once removed, make note of the length of thread showing on the right and left tie rod. Adjust as needed once the right is swapped to the left and vice versa.

Image shows a correctly reversed tie-rod ready for reinstallation into the steering rack.

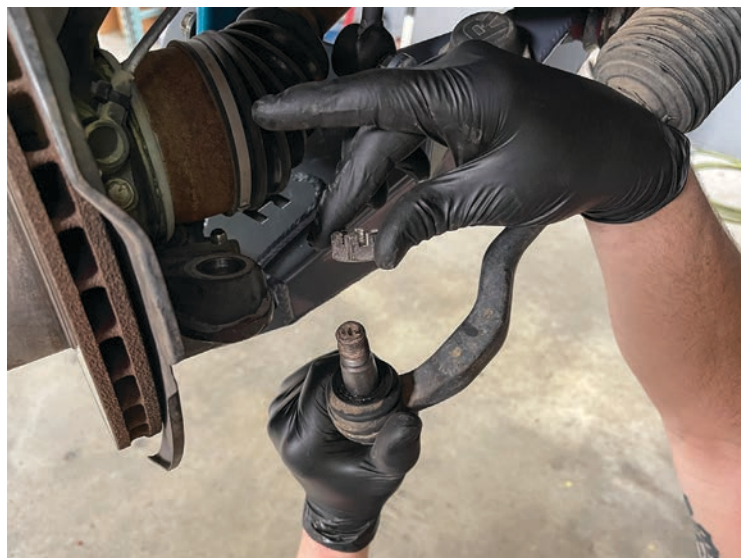
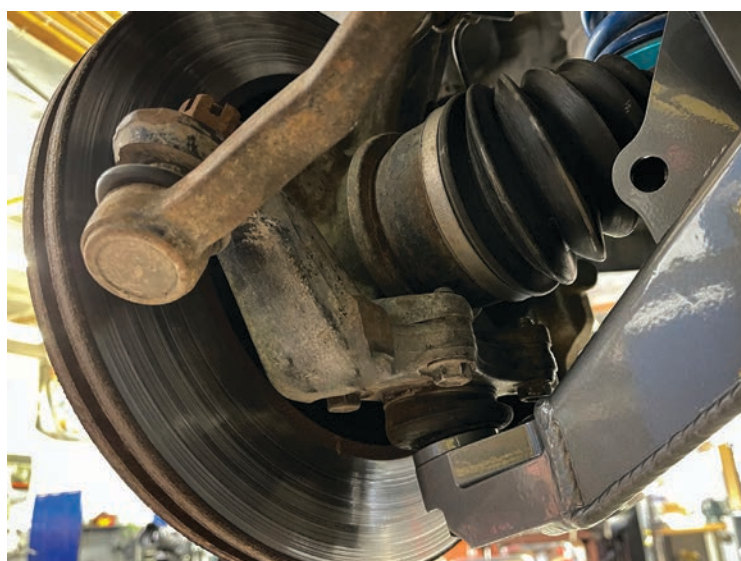
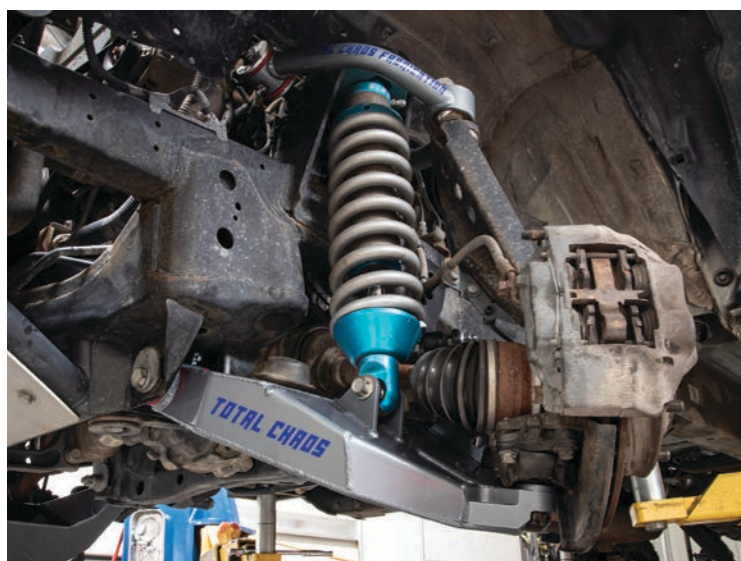
STEP 24

Reinstall the tie-rod into the factory lower ball joint and torque the tie rod nut ball joint to factory spec (67ft/lb).

Then install a new cotter pin through the tie rod castle nut.
