# INSTALLATION INSTRUCTIONS

# COMPONENT: STOCK LENGTH LOWER CONTROL ARMS

2004-2006 TOYOTA TUNDRA 2004-2007 TOYOTA SEQUOIA

PART #: 97554-E

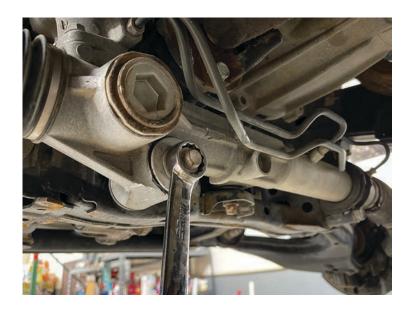
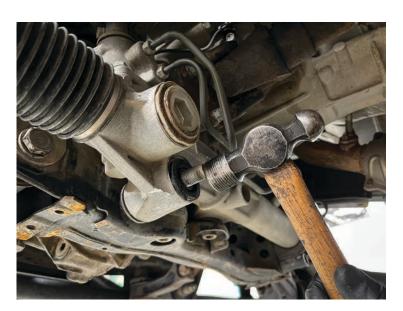
Use a 22mm wrench to loosen and remove the nut from the steering rack through bolt. Tap the bolt forward so that it no longer goes through the steering rack.

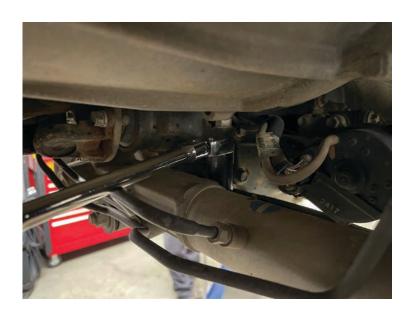
# STEP 3

Use a 19mm socket to remove the final rack bolt that is under the bellhousing and faces downward.

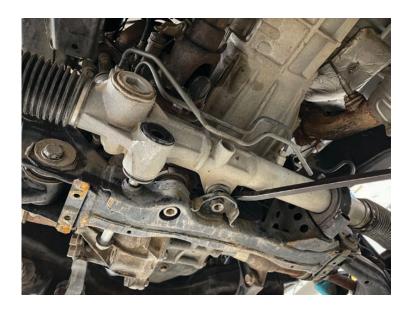
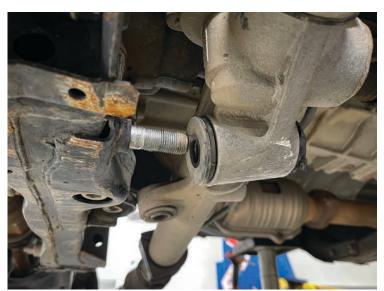
With the rack hardware removed, pull the rack back and out of the way of the lower control arm hardware.

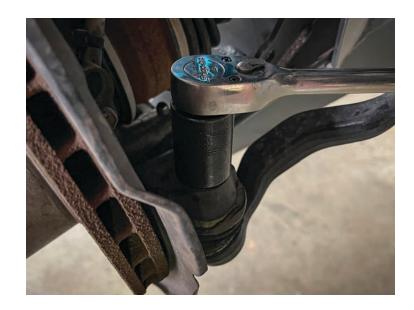
Loosen the castle nut but do not fully remove it.

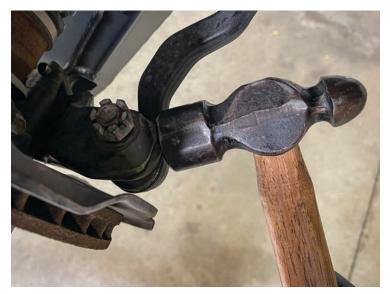
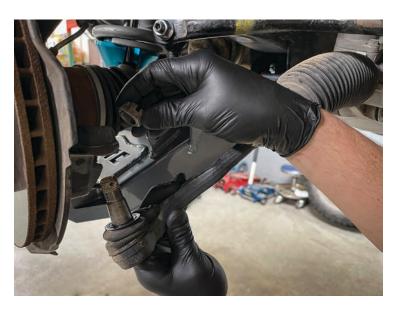
# STEP 7

Strike the lower ball joint to knock the tie-rod taper loose. Once it pops free, remove the castle nut and separate the tie-rod from the lower ball joint.

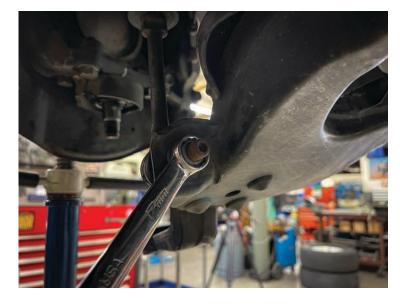
If a sway bar is on the vehicle, remove the hardware that connects it to the lower control arm.

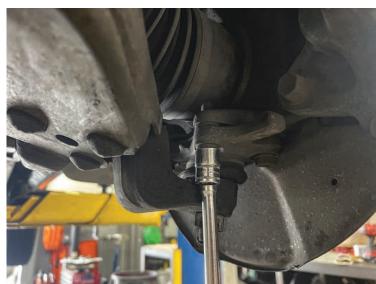
#### STEP 9

Remove the (4) 17mm head bolts holding the old ball joint to the steering knuckle.

It is unnecessary to fully remove the old ball joint from the factory lower control arm since you'll be replacing them with new ones.

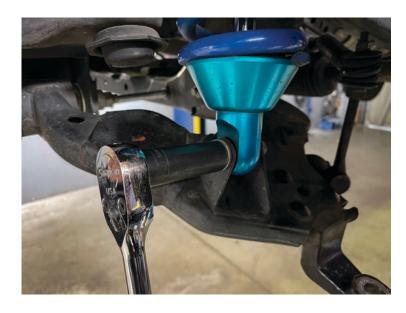
Use a 19mm to loosen and remove the lower shock bolt.

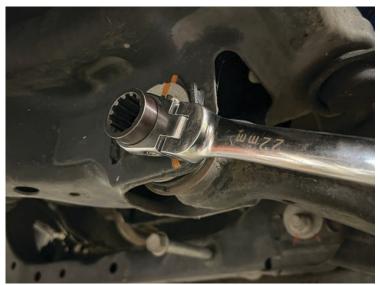
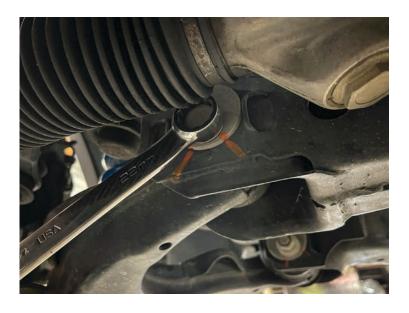
# **STEP 12**

Supporting the arm in one hand, loosen the lower control arm eccentric cam bolts, and lower the arm letting it hang.

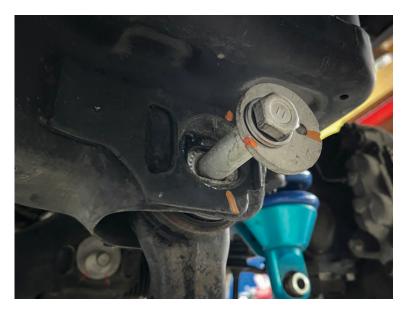
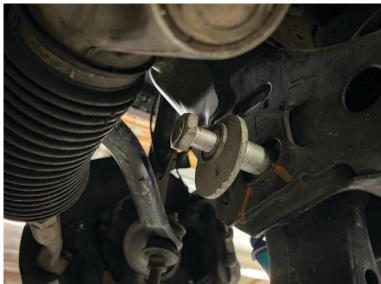
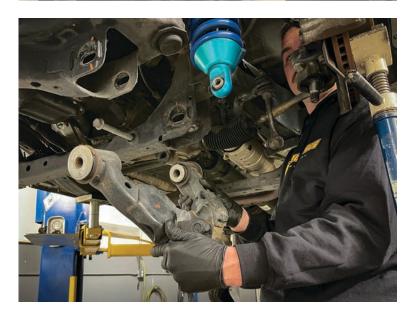
Support the control arm as you remove the cam bolts to completely remove the arm from the vehicle.

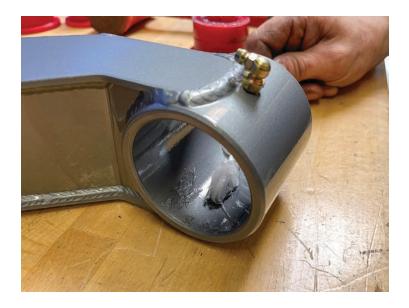
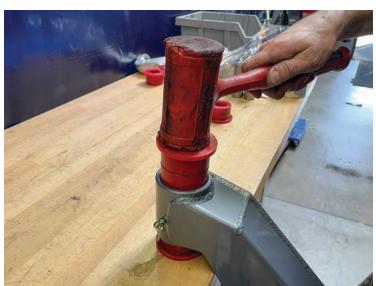
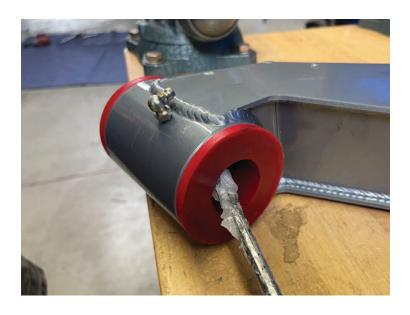
Grease and install the new bushings and inner sleeves.

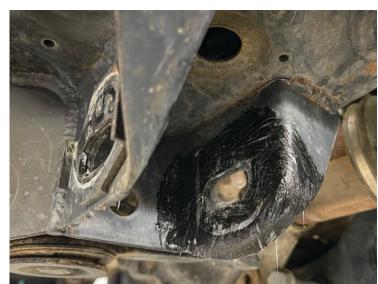
### **STEP 15**

Grease the frame pocket where the LCA bushings will ride on the frame.

NOTE: It may be necessary to use a rubber mallet to slightly open up the frame pockets to ease the installation of the new lower control arm.

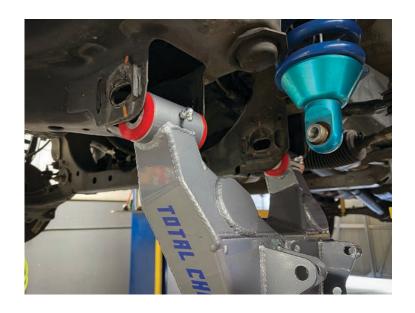
### STEP 16

Slide the new control arm into the frame and reinstall the alignment cam hardware.

Then reverse steps 1-4 to reinstall the steering rack.

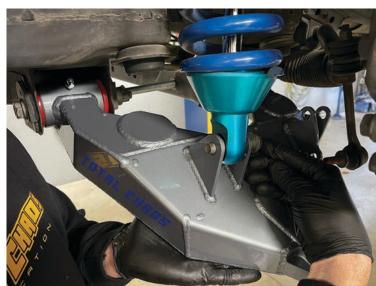
### **STEP 17**

Swing the new LCA up and reinstall the lower shock bolt so the arm will be held in place.

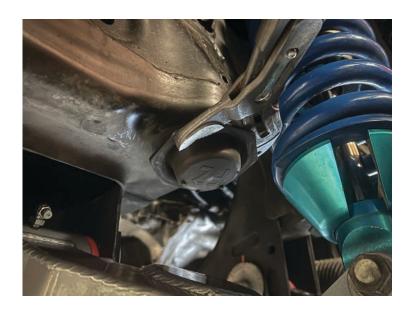
# STEP 18

Remove the factory bump stops by unscrewing them from the frame using large pliers.

NOTE: There are two bump stops on each side of the vehicle. They will line up with the circles on top of the lower control arm.

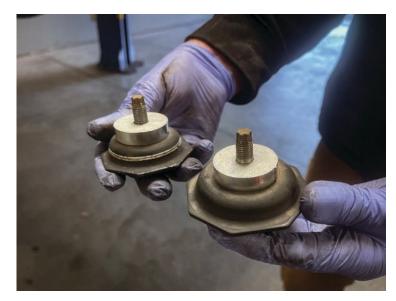
Place the provided bump stop spacers on the bump stops.

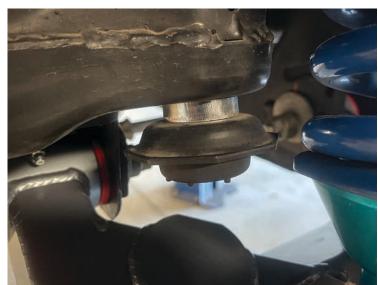
### STEP 20

Put blue Loc-Tite on the threads before reinstalling them on the vehicle.

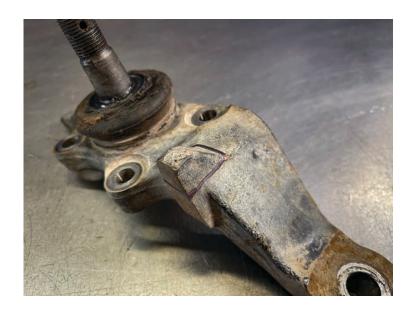
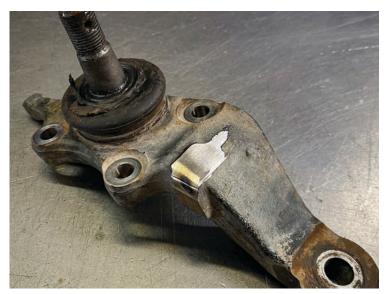
Trimming the new factory lower ball joint steering stop is necessary for clearance purposes.

The nub to trim down is marked with a sharpie. A band saw and a belt sander will work best.

Once trimming the sanding is complete, use black spray paint to coat the exposed area.

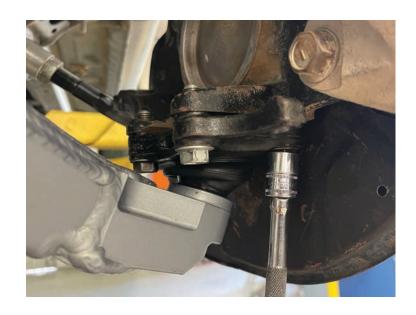
Using Red Loc-Tite, reinstall the (4) lower ball joint bolts into the knuckle and torque to 59 ft/lbs.

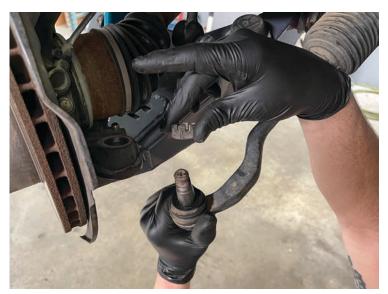
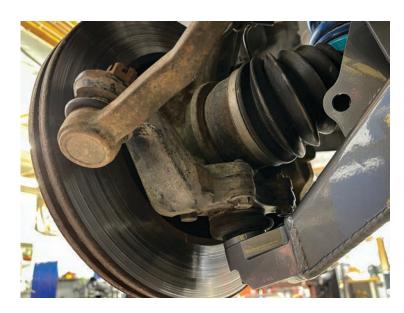
### **STEP 25**

Reinstall the tie-rod into the factory lower ball joint and torque the tie rod nut ball joint to factory spec (67ft/lb).

Then install a new cotter pin through the tie rod castle nut.
