INSTALLATION NOTES

PARTS LIST: 08+ LANDCRUISER UPPER CONTROL ARM			
ITEM #	PART #	QTY.	ITEM DESCRIPTION
1	87504L	1	CONTROL ARM, 08+ LANDCRUISER UPPER LEFT
	87504R	1	CONTROL ARM, 08+ LANDCRUISER UPPER RIGHT
2	60684	8	BUSHING, URETHANE HALF
3	69707	4	INNER SLEEVE
4	10005	4	FITTING, GREASE (ZERK)
5	69720	8	WASHER, PLATED PIVOT END
6	10242	2	BOLT, 9/16" x 4.00L FLANGE HEAD
7	100916C	2	SPACER, 9/16" MISALIGNMENT
8	10034TCF	2	SPACER, 3/4" MISALIGNMENT
9	30005	2	SLEEVE, 9/16" TAPERED ADAPTER
10	12204	2	WASHER, 9/16" SAE
11	11202	2	NUT, 9/16" C-LOCK

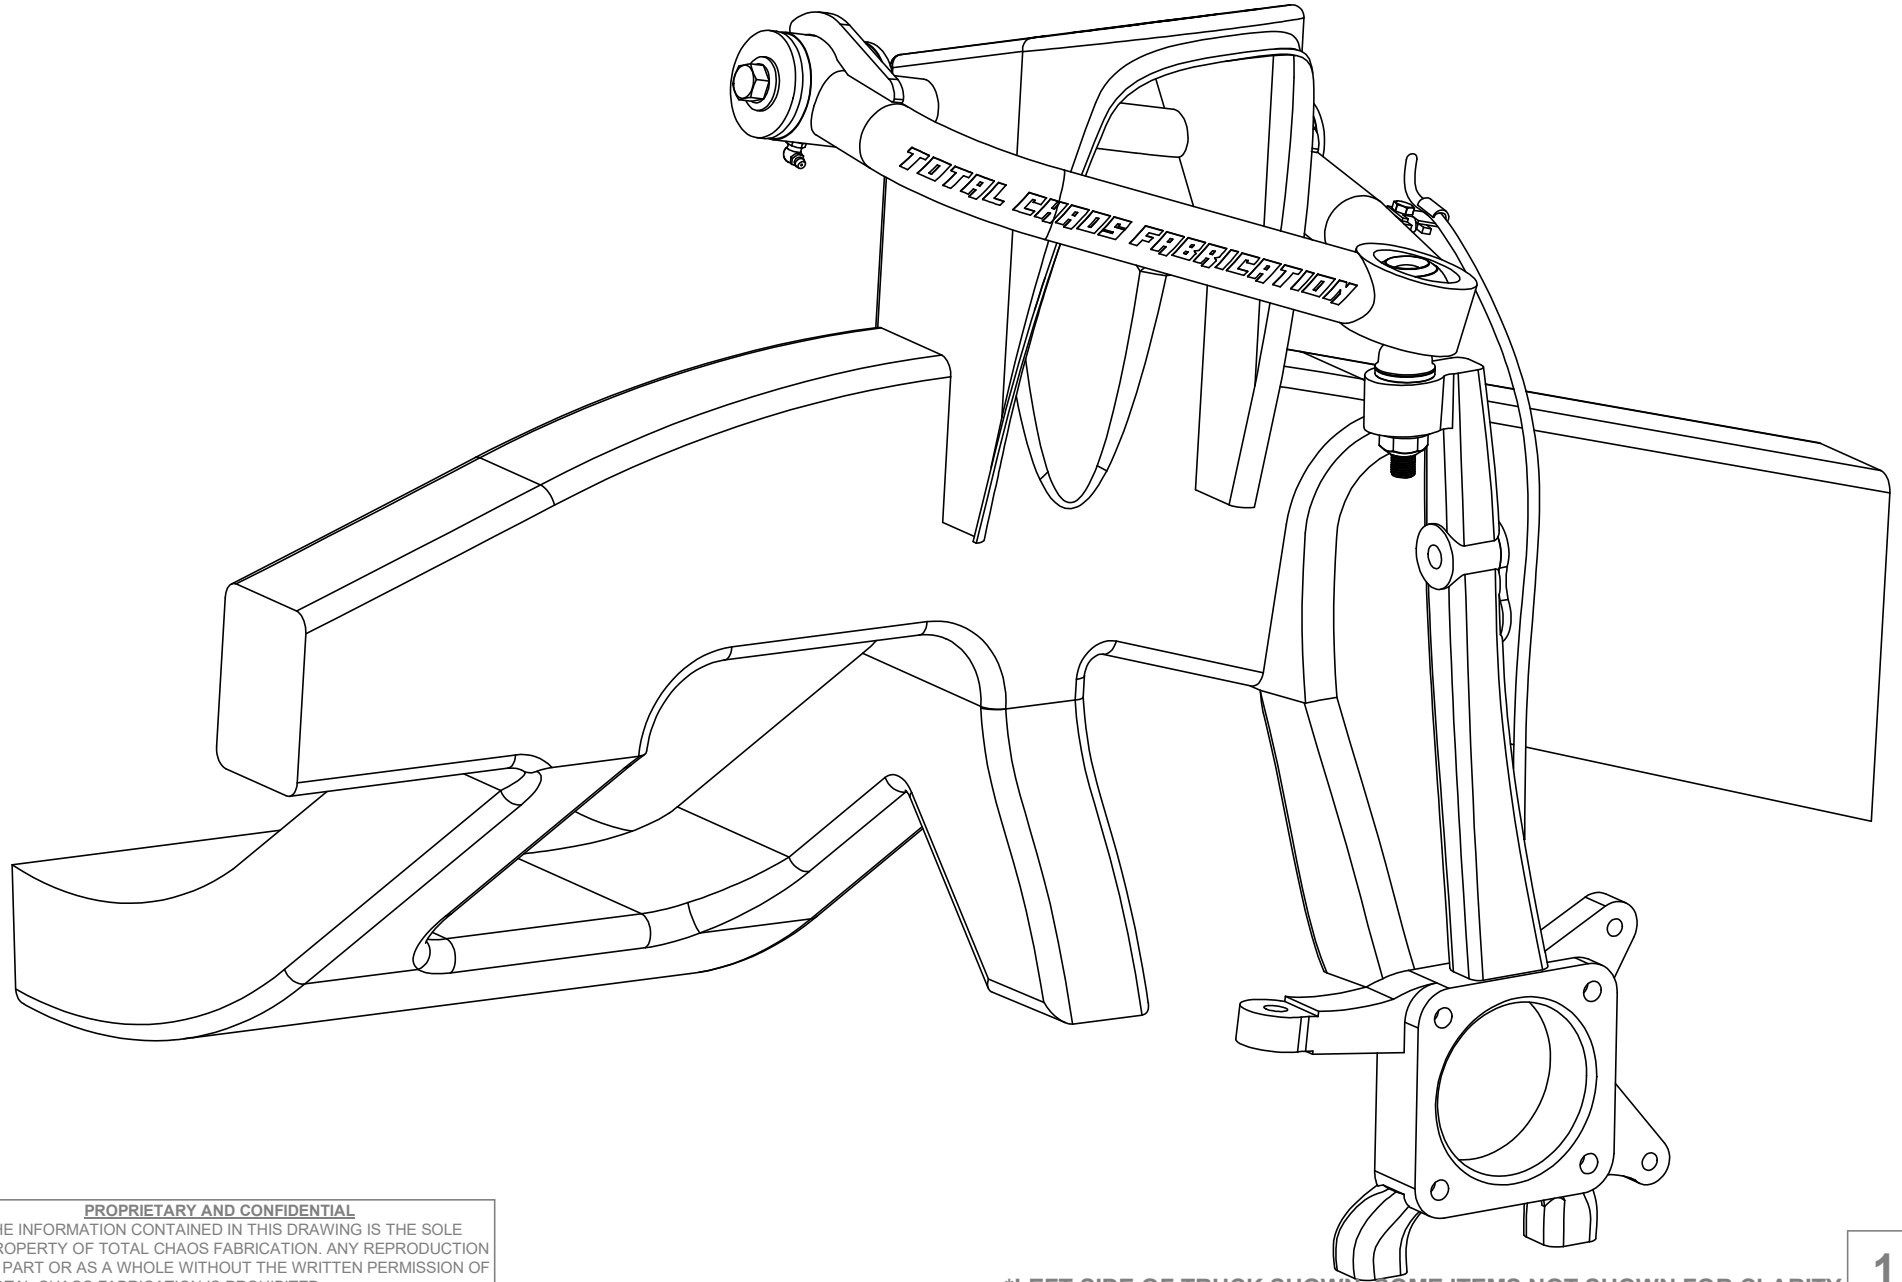
*LEFT SIDE OF TRUCK SHOWN. SOME ITEMS NOT SHOWN FOR CLARITY.
